Keracis® Omega3 Wound

Intact fish skin grafts for tissue regeneration

Dehiscenced surgical wound with exposed bone and tendon

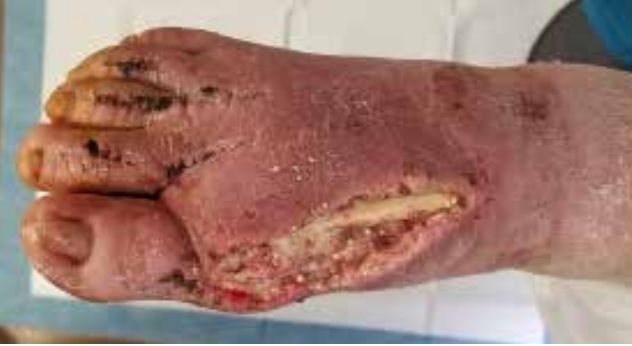
1 WEEK PRIOR

After first bunion surgical procedure. Patient was readmitted to hospital after injury to the original location. Incision and drainage with antibiotic bead placement.

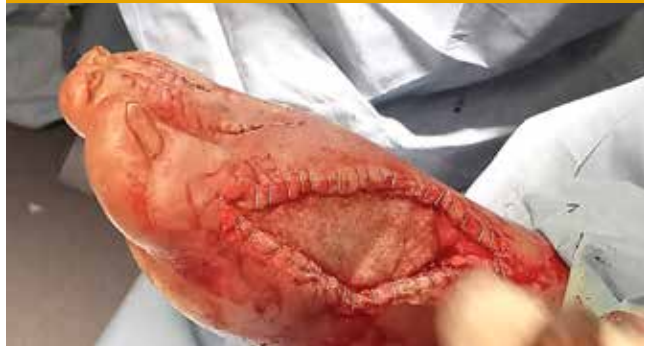
DAY 1

The first application of **Kerecis® Omega3 Wound** after incision and drainage.

The Kerecis® Omega3 Wound graft is cut to size and secured, scale side up, with staples to the sharply debrided wound edges. This provides tight apposition of the graft to the wound bed for optimal cell ingrowth and skin regeneration.

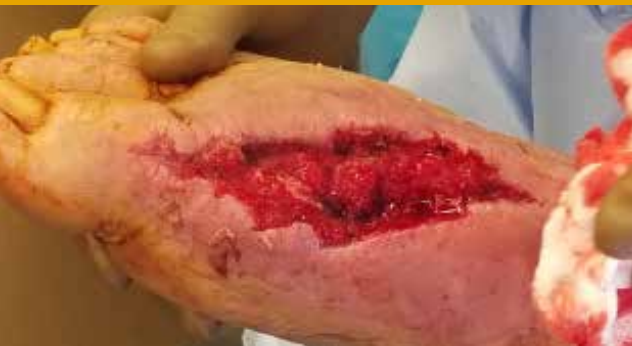
DAY 19

Wound status 19 days after the first **Kerecis® Omega3 Wound** application. Wound prepared for second application.

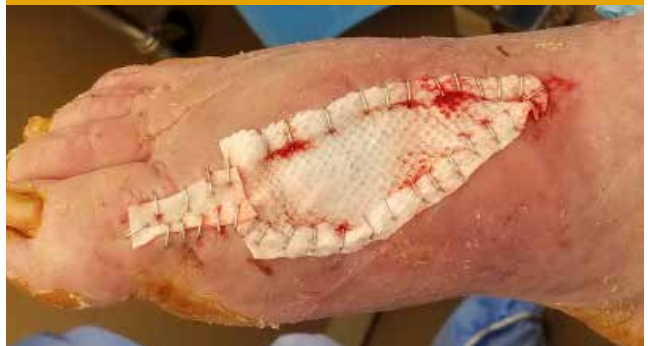
DAY 19

Second application of **Kerecis® Omega3 Wound** in place.

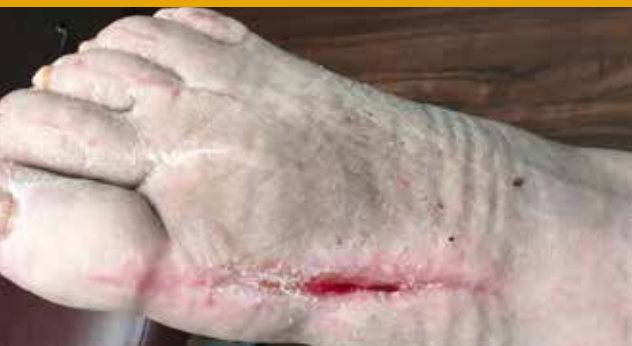
DAY 67

The wound is healing well with **Kerecis® Omega3 Wound** integrated 30 days after third staged surgery.

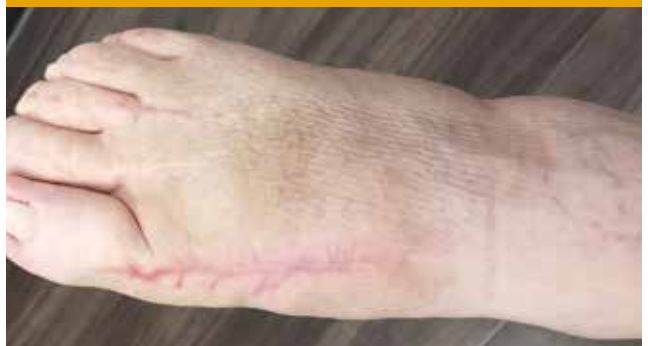
DAY 101

Wound healed with minimal scar contracture.

Complete wound healing was achieved without further tissue necrosis and with minimal scar contracture. The wound was fully closed fourteen weeks after the original Kerecis® Omega3 Wound application. Kerecis® Omega3 Wound is an effective tool for post-operative wound dehiscence caused by infection.
